AM 88-18

**Evaluation of Head and Face Injury Potential
of Current Airline Seats
During Crash Decelerations**

June 1966

**OFFICE OF AVIATION MEDICINE
FEDERAL AVIATION AGENCY**

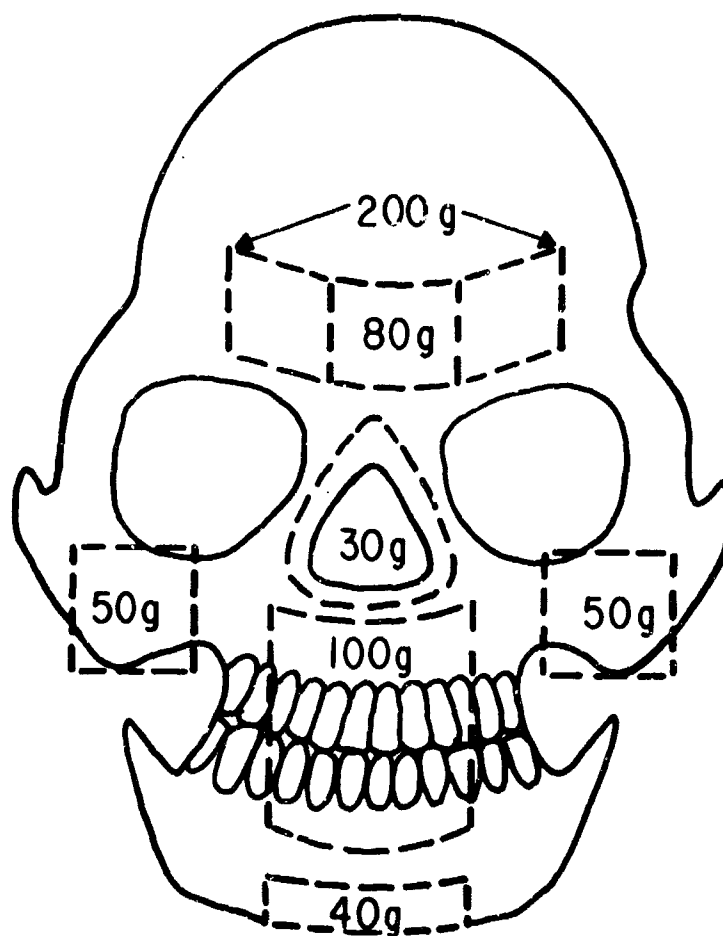
FIGURE 1. Summary of maximum tolerable impact forces on a padded deformable surface.

Figure 1 reproduces summary data² showing the tolerances of the human face and head to

resist fracture during impact against *deformable structures*.

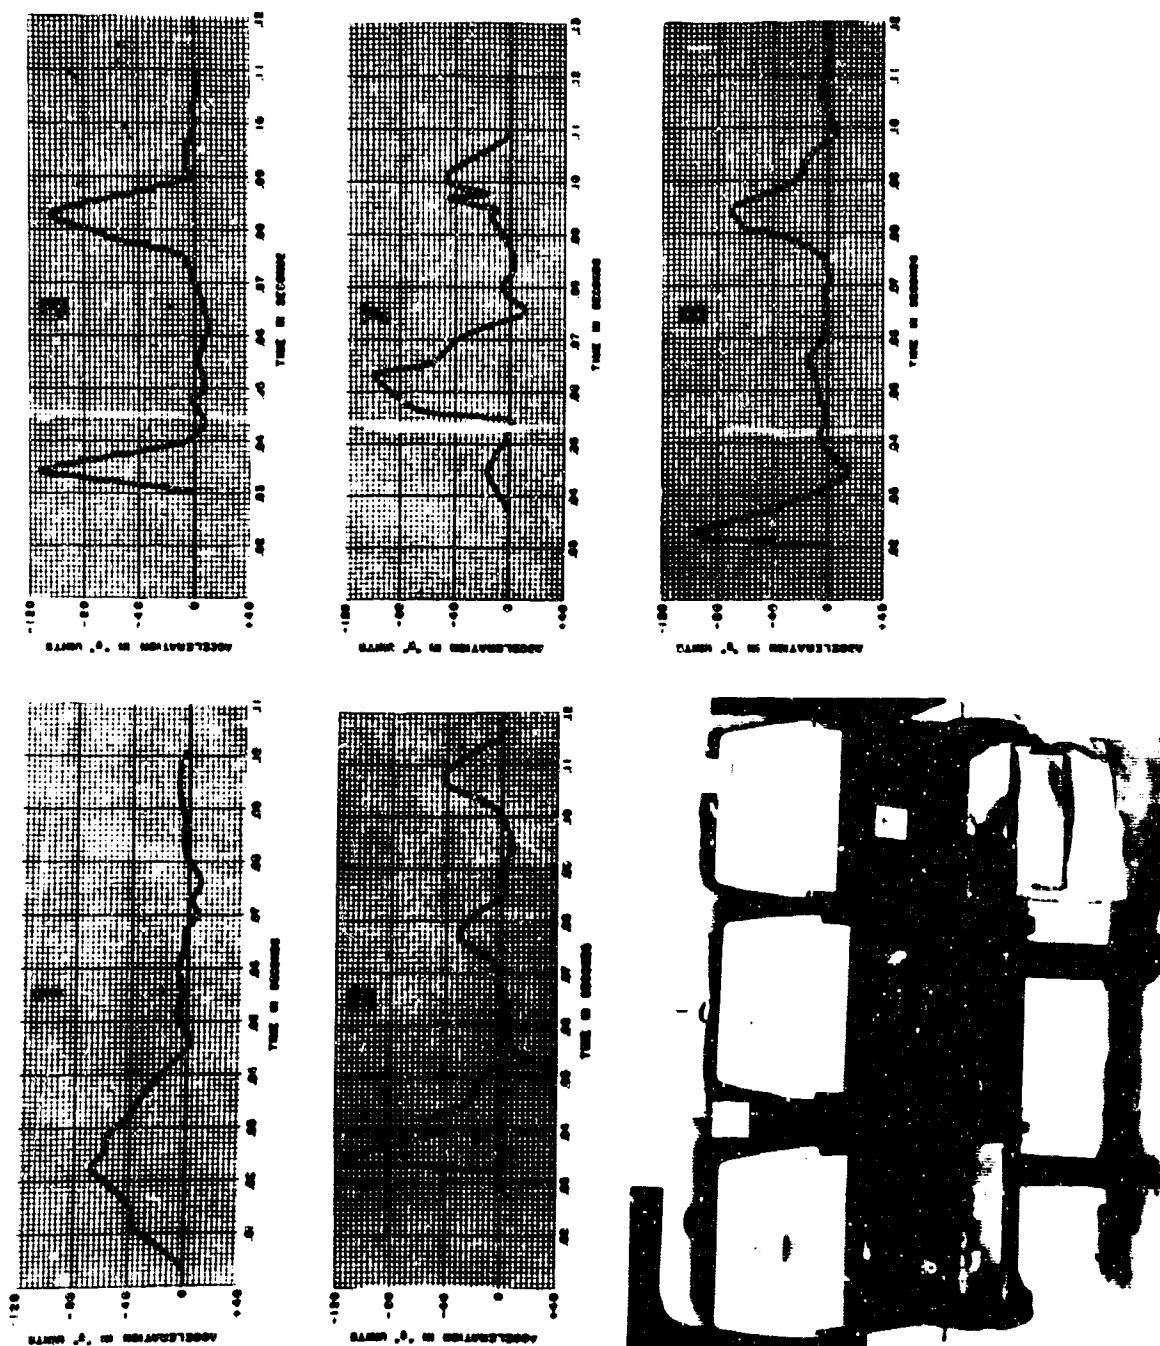
FIGURE A1. Seat A.

Five impacts of the dummy head were made against Seat A at the points shown in Figure A1

(Figures A1 through A10 are in the Appendix.) by numbers 1, 2, 3, 7, and 8. Corresponding "g" time-force curves are presented. Impact #1 (on the top of the middle seat) produced a sizeable deformation in the soft metal structure. The metal deformed readily and *contoured* to the head, distributing the force over a large area of the skull. The peak force was about 70g with a slow rise time (20 milliseconds). The deceleration extended over 40 milliseconds. Referring to Figure 1, we would expect this impact to produce no bony injury if struck by the forehead or teeth-maxilla areas, but it would be of sufficient force to fracture a single zygomatic (cheek bone), nose, or mandible (jaw bone). In all five instances, however, the passenger would be rendered unconscious.²

Impact #2 was between the left and middle seats with the seats in the upright position. Most of the force (120g peak) was used in forcing the seat backs to break forward. There was little deformation of the seat structure, causing the impact loads to be concentrated on a small area of the head. This would have produced fatal fractures. It is of interest that a steady pull of only 10 to 12 pounds is needed to force one of these seat backs forward.

Impact #3 against the center of the serving tray in the left seat back (with the seat upright) produced two peaks of over 100g: one when the seat back was forced forward and the other when the head subsequently struck the lower cross member of the seat back. There was no deformation of the serving tray. Estimates of injury potential presented in Table 1 are based on a previous report² and the area of contact of structure with the head. For injury estimates for the following figures, refer to Table 1.

Some seat-design engineers feel that under actual crash conditions the "break-away" type of seat back will fold forward from its own momentum out of the way of the head. If this is true, the head possibly will strike the lower portion of the seat back or a tubular cross member. Impact #7 simulates this condition. The right seat back was impacted in the forward position. In the graph for #7, the first small peak of about 15g was produced in bending the thin metal at the bottom of the seat before the head made contact with the heavy tubular cross member concealed beneath it. At that time a very lethal, long-duration (20 milliseconds) force of over 100g was applied to the head.

Impact #8 was against the top of the right seat back (seat upright) at the top edge of the serving tray. Note similarity of curves 3 and 8.

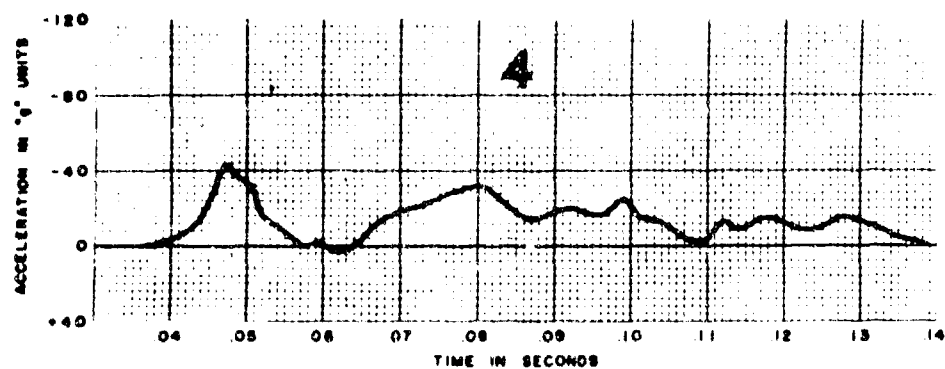
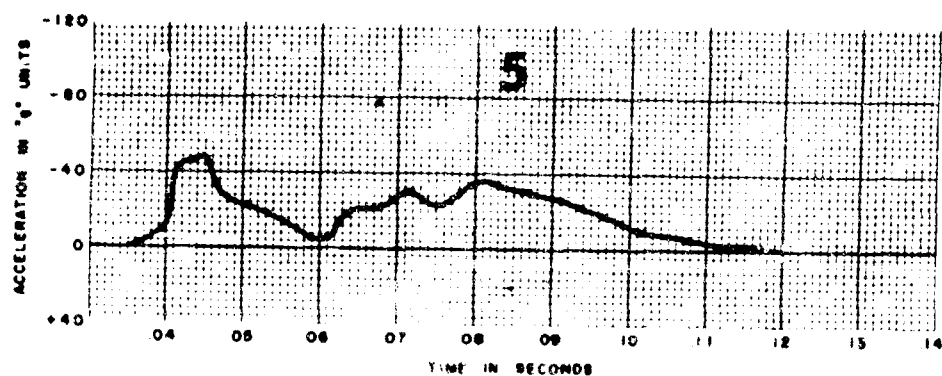
FIGURE A2 - Seat A.

Since the arms supporting the folding serving trays have broken off in some airline crashes and caused serious injury, two impacts were made on the unfolded trays of Seat A (Figure A2). Impact #4 was centered in an area between the left and center trays, whereas impact #5 was against the right edge of the left seat tray. The tray support arms in both cases bent several inches but did not fracture. The impacts produced long duration forces of about 40g or less.

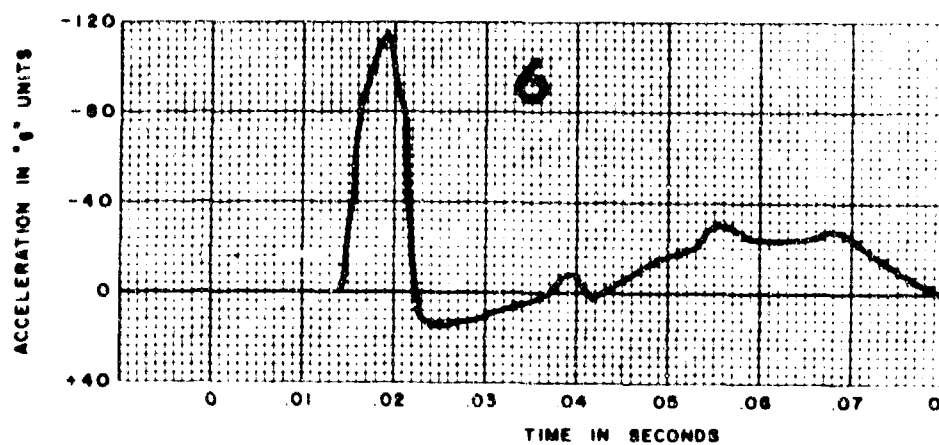
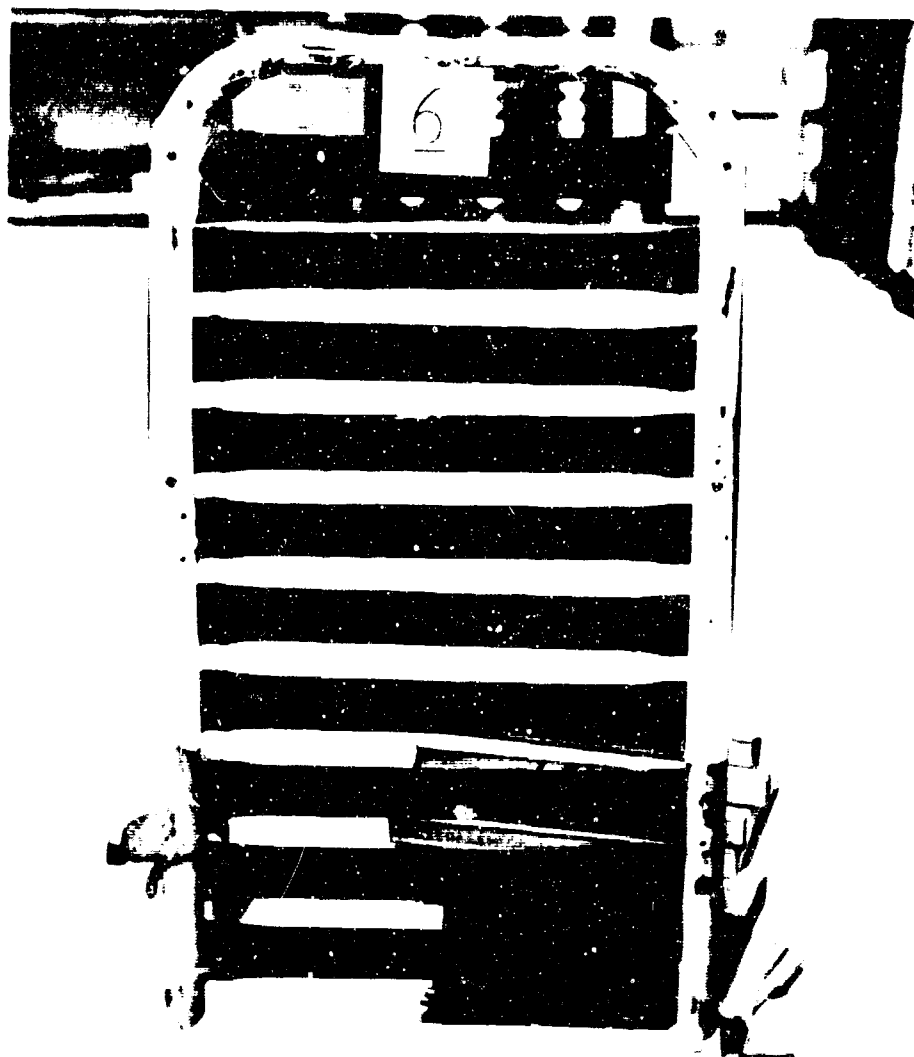
FIGURE A3. Sent B.

In Figure A3, the dent left by the head impact against the top tubular structure (Seat B) is barely visible in the photograph. The sharp

rising 120g peak force applied to an area of not more than 1 sq in. of the head would undoubtedly have caused fatal injuries.

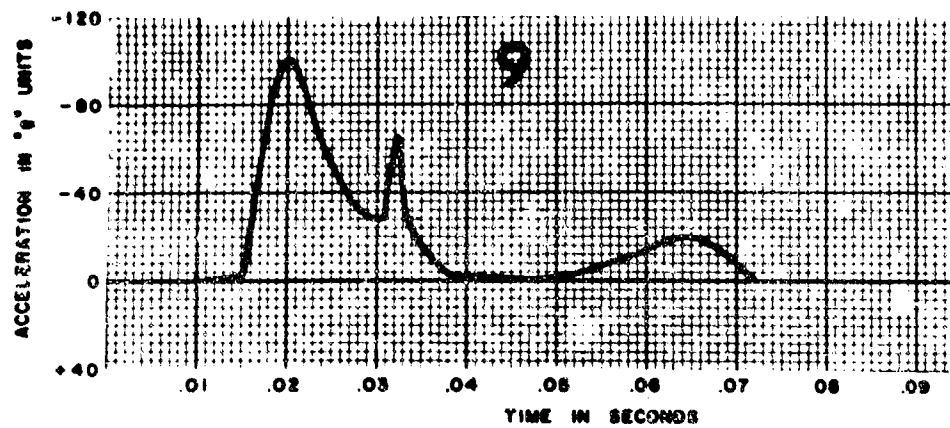
FIGURE A1 - SEAT C

Impact #9 against the top edge of Seat C produced a somewhat larger dent (Figure A4). The g-force curve looks almost as severe as the one in Figure A3; however, there is one important difference. Since the metal did deform and contour to the curvatures of the head, the pressure in pounds per square inch on the head would be much less than in the previous figure and the danger of injuries reduced accordingly.

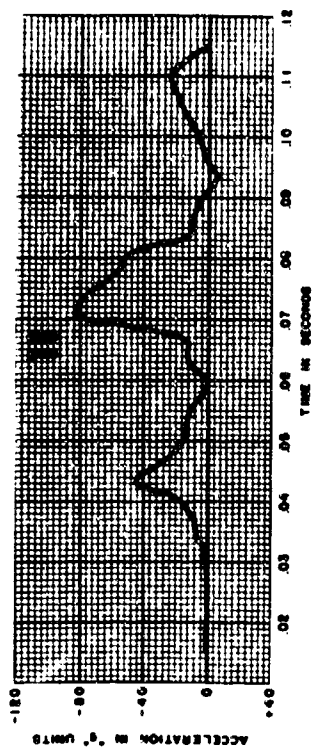
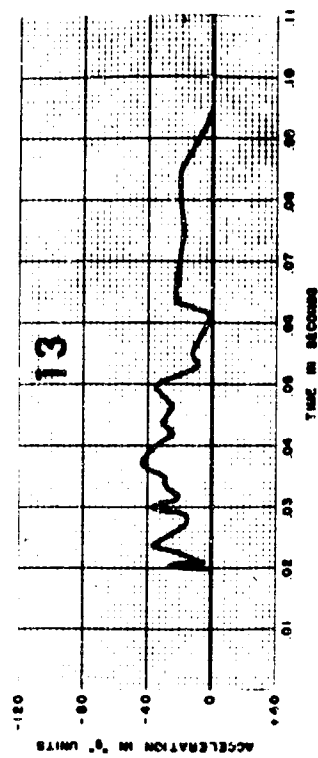
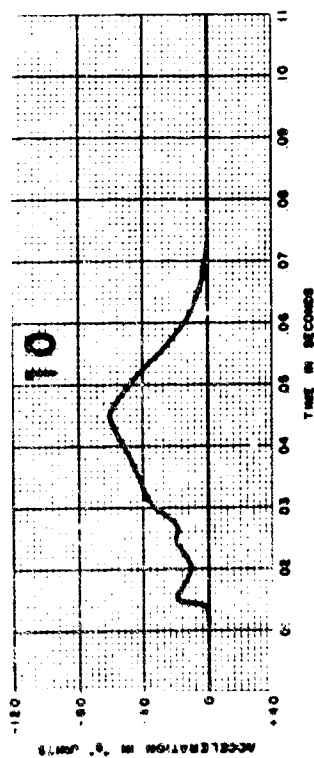
FIGURE A5. Seat D.

Three impacts against Seat D in Figure A5 show that it is a fairly safe seat for head impact. The top edge of the left seat back (test #10) deformed 11 inches and contoured perfectly to the head. Note that initial bending of the structure started at 20g and that the force is spread out with a slow rise time and a peak of not over 60g. Test #13 against the top rear surface of the right seat back shows a more desirable pattern. The head did not experience over 40g; however, test #11 against the tubular cross member at the bottom of the right seat back produced peak forces in excess of 80g. Throughout this report this type of tubular structure is shown to be very dangerous and undoubtedly causes a large number of head and leg fractures. This area of the seat requires additional safety-design consideration.

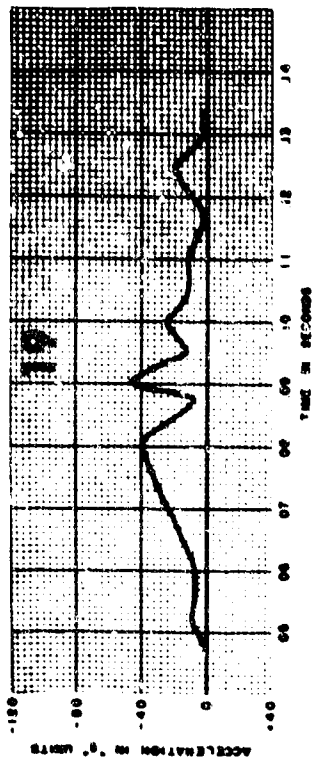
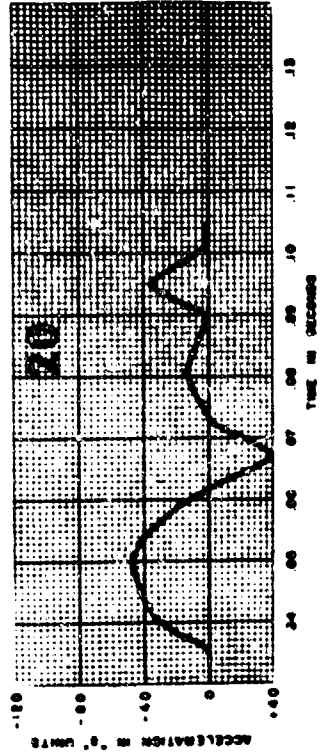
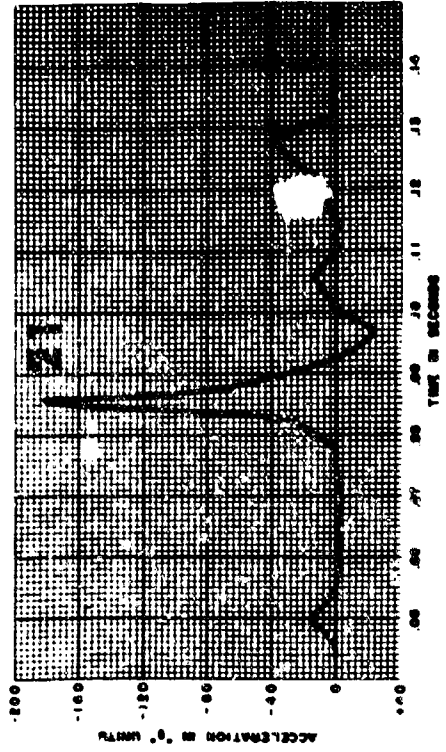
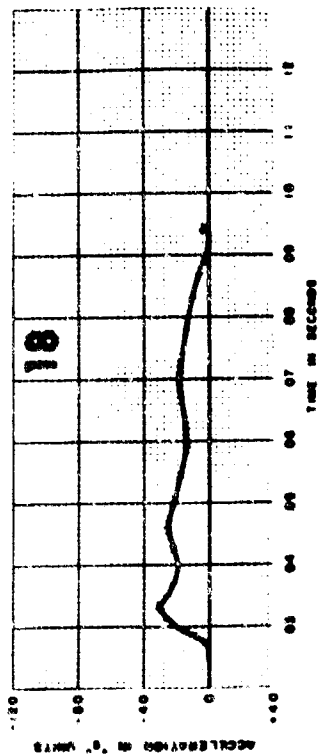
FIGURE A9. Seis E.

Seat E in Figure A6 (mostly fabricated of sheet aluminum) is shown by the force curves to have very good deforming characteristics with the exception of the lower tubular cross member, which produced fatal impact forces of 180g.

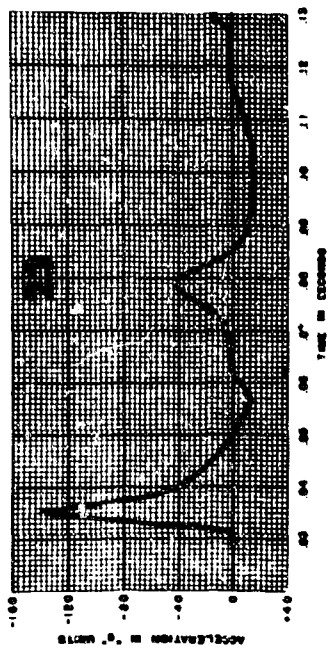
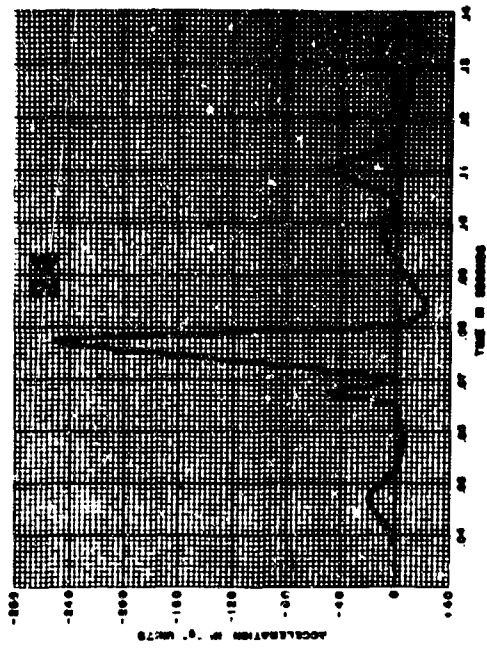
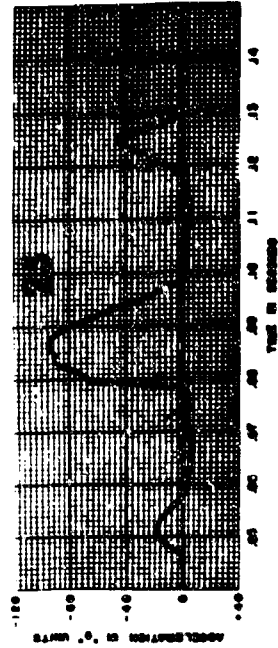
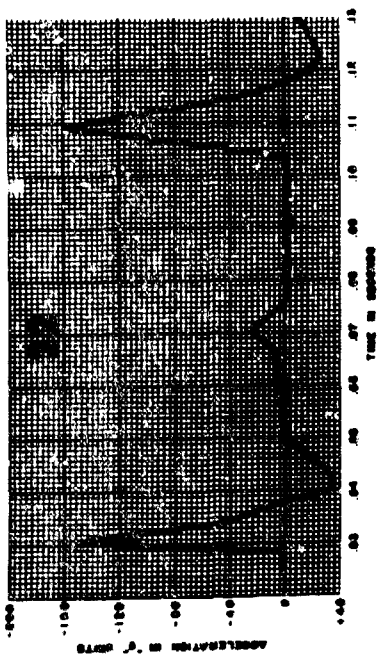
FIGURE A7. Seat F.

Seat F (Figure A7) is constructed of aluminum tubes and produced high forces during all impacts. The most dangerous part of the seat, however, is the aft end of the rigid seat arm protruding rearward between the seat backs. Test #24 against one of these arms produced a peak force of 250g.

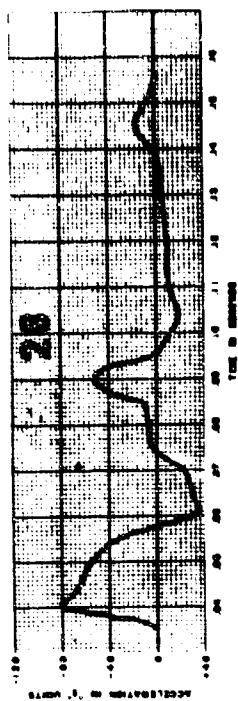
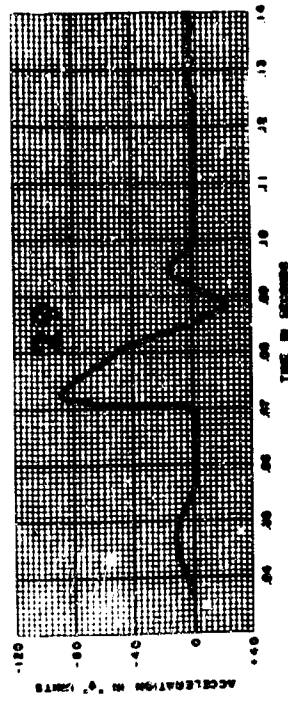
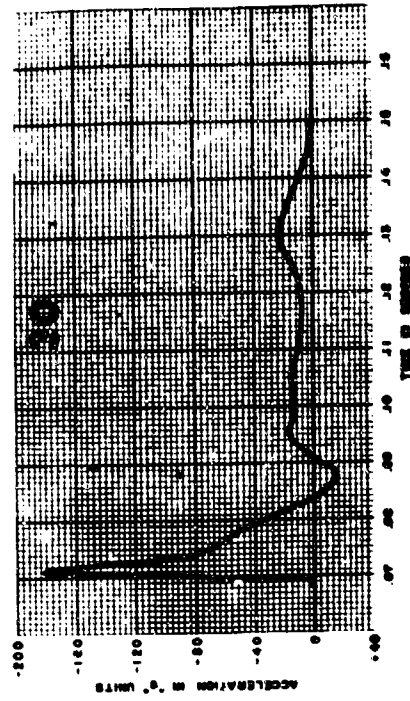
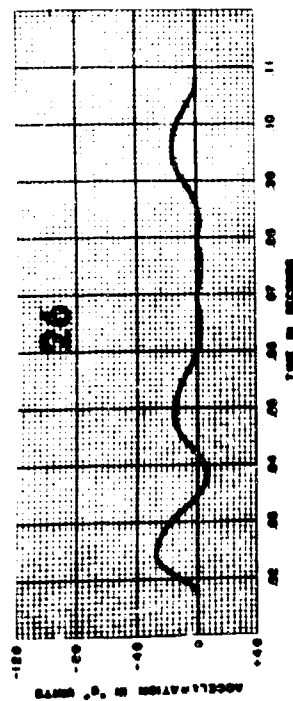
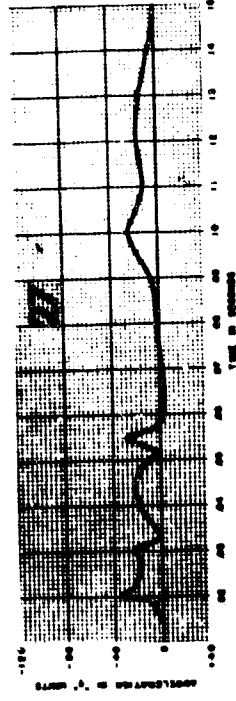
FIGURE A8. Sent G.

Seat G (Figure A8), similar in construction to that shown in Figure A4, produced low g-forces on the upper structure but again pointed out the danger of the rigid arm (test #30—180g).

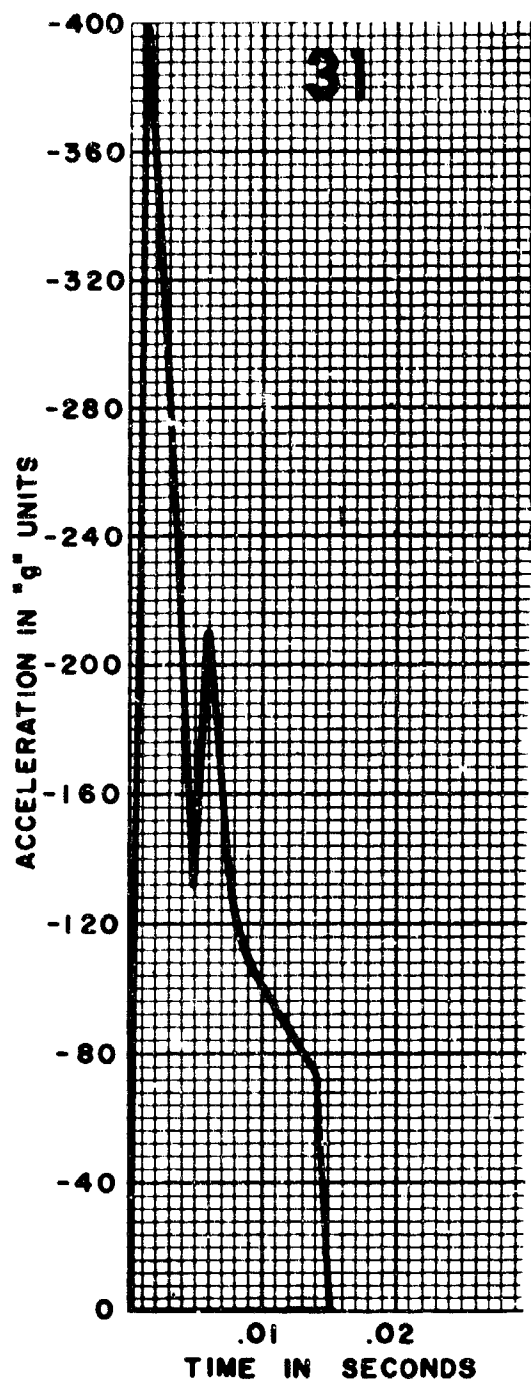
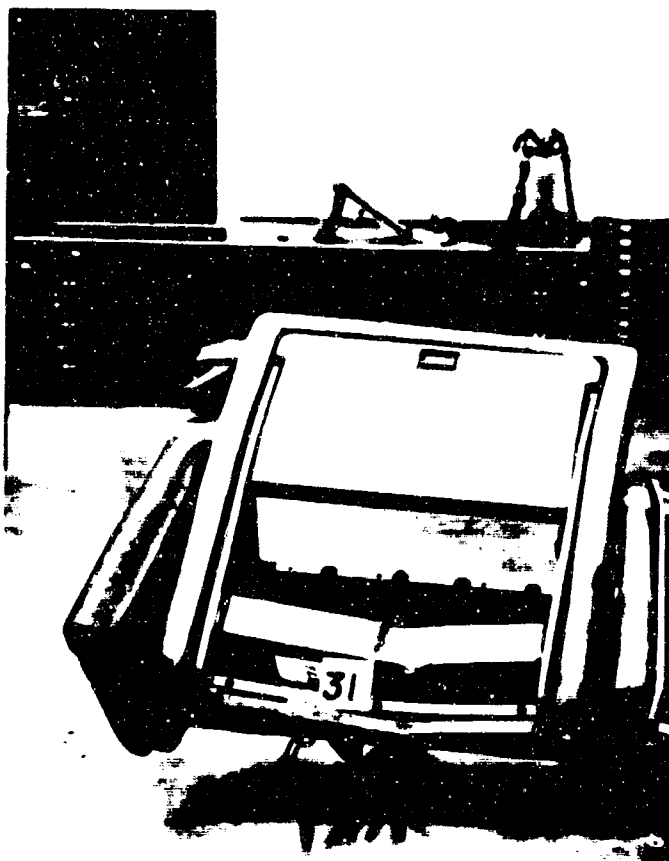
FIGURE A9. Seat H.

Seat H has two heavy, square-edged, tubular structures in the lower portion of the seat back. Tests #31 (Figure A9) and #32 (Figure A10) show unusually high g-forces when these rigid structures are impacted. The top of the seat back is also of square tubular construction and

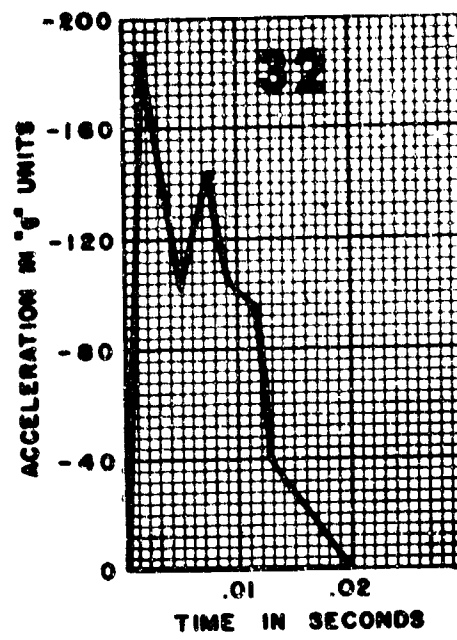
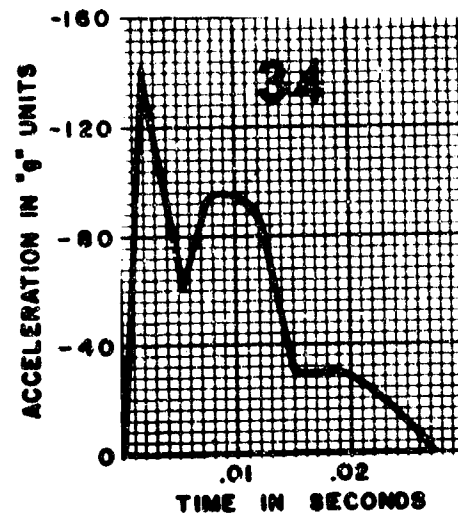
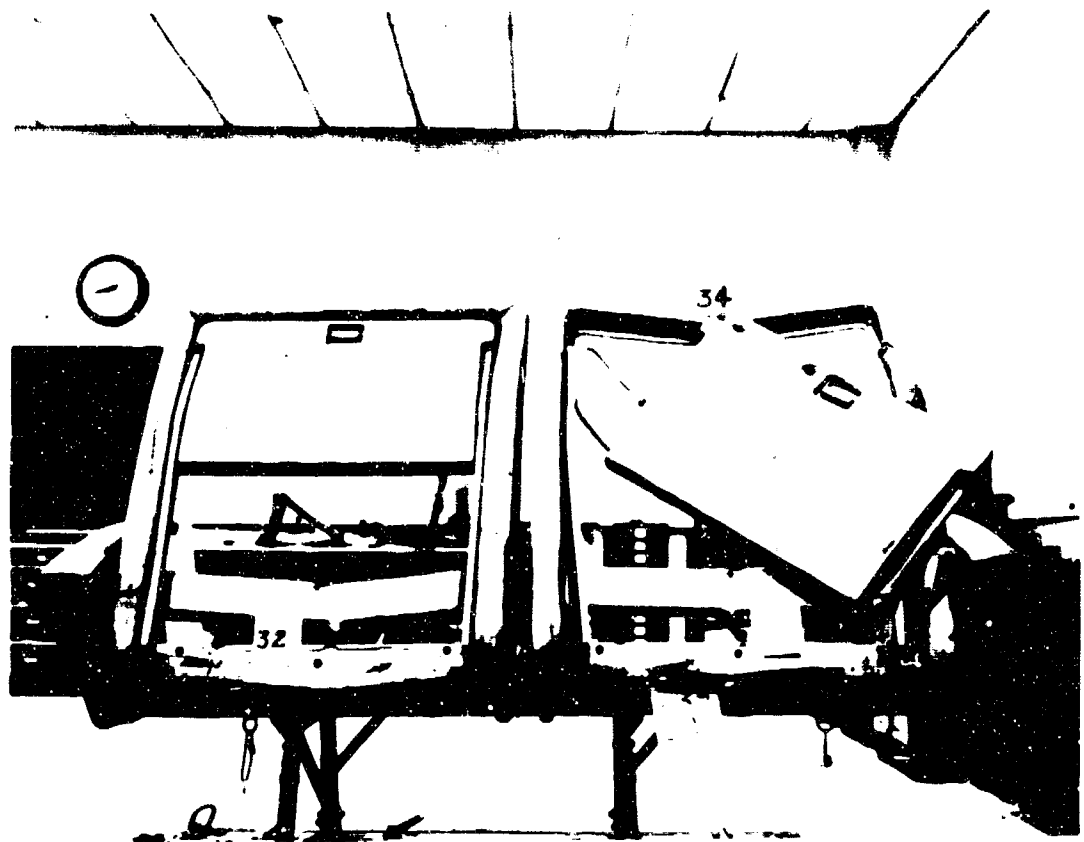
FIGURE A10. Seat II.

produced 140g when impacted (#34, Figure A10).
